SERVICE BULLETIN – V-THROTTLE

V-Throttle lever update

MANDATORY

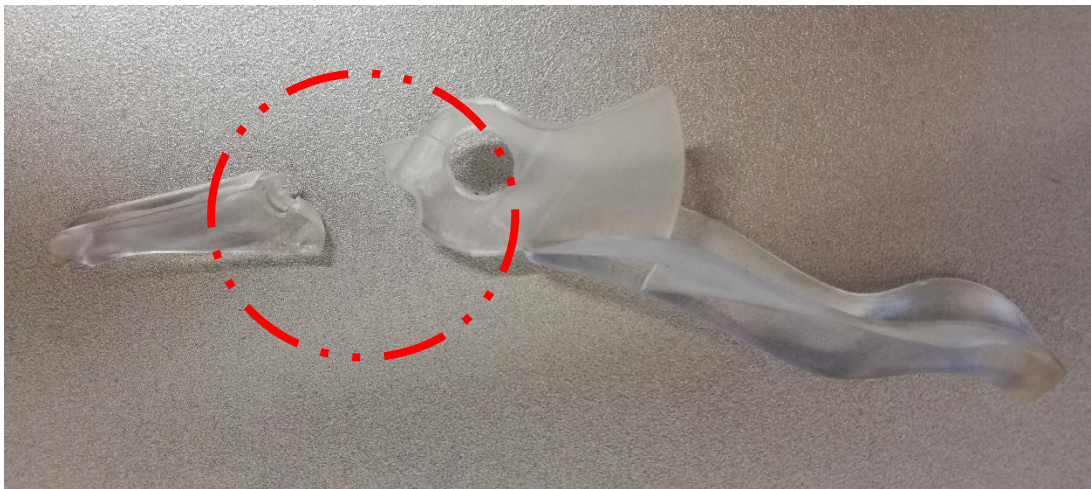
There have been a few instances of failure on the V-Throttle. The failure has occurred on the lever which breaks at its weakest point (see image below). As a result of the failure the pilot may lose control over the throttle and the engine.

- Most cases occurred on colored levers (orange, green, transparent). The lever will no longer be manufactured with these materials because the colored pigment can weaken the material.
- Very rare cases have also occurred on black levers.
- Very rare cases due to a non-optimal throttle installation. Detailed instructions have been issued to install and use the throttle in the safest conditions.

For these reasons the geometry of the lever has been modified to reinforce it. The new lever will be supplied only in black color to prevent any material weakness.

The new lever has been in production since March 2021. To ensure maximum safety for all customers the company has decided to replace all old levers with previous material and geometry.
