SERVICE BULLETIN – ATOM80

Exhaust support plate

1P04-0021_01 - Assembly procedure for exhaust support bracket

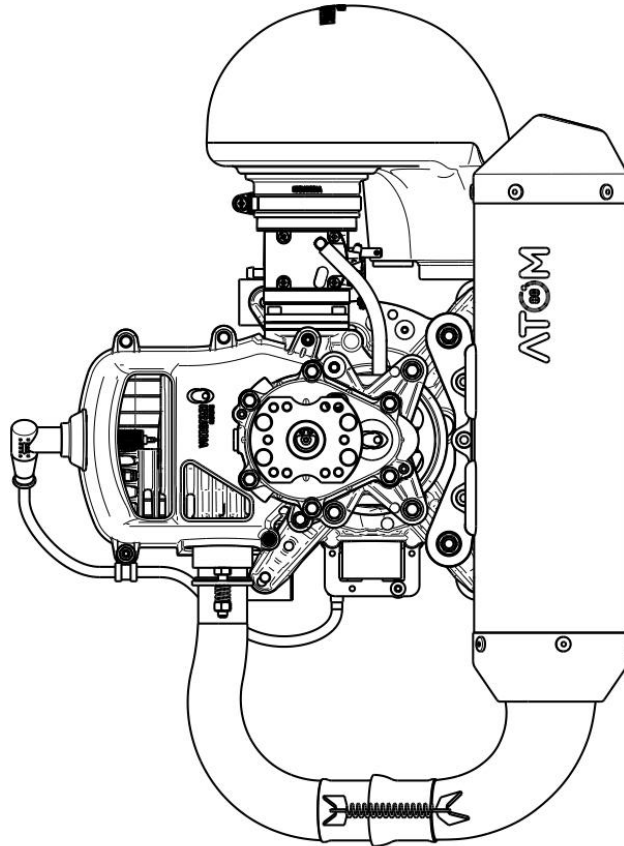
CODE: AT186

It has been found on some engines that the exhaust plate code AT186 has broken after hours of operation. The plate has been reinforced: the geometry has been changed and the thickness has been increased to give greater resistance. Material and fastening are unchanged.

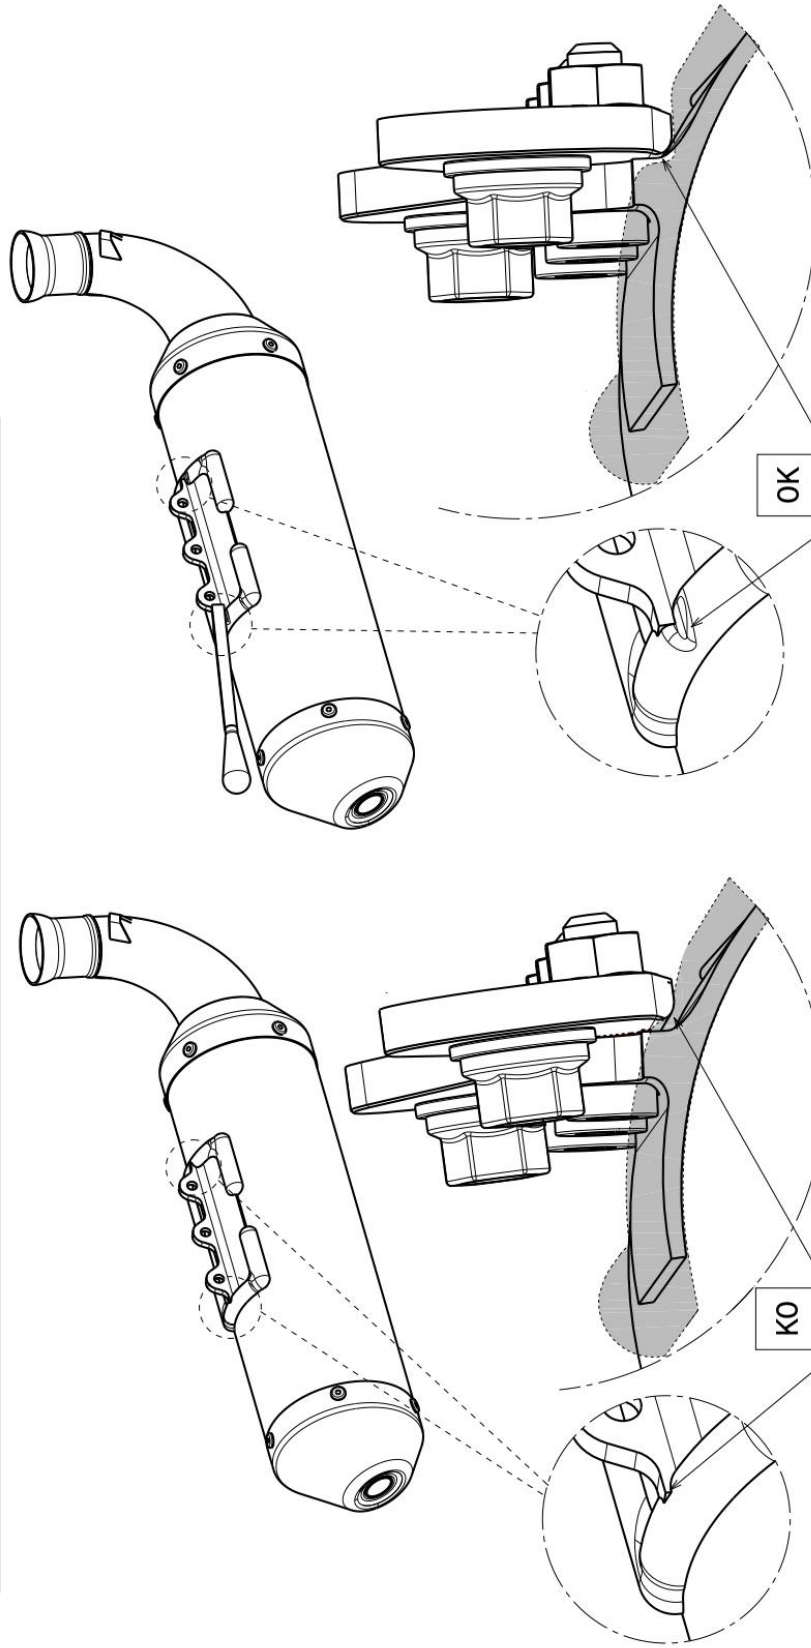
1.

- No contact between plate and welding
- No gap between plates

- Interference between plate and welding
- Imperfect contact or gap between plates

Weld filings may be required in the area of contact with the plate.

Check the welding in the indicated areas.
If you notice interference between the plate and the welding,
remove the weld excess with a file.
