Safety conditions and devices of the MY19 Airbox

MANDATORY

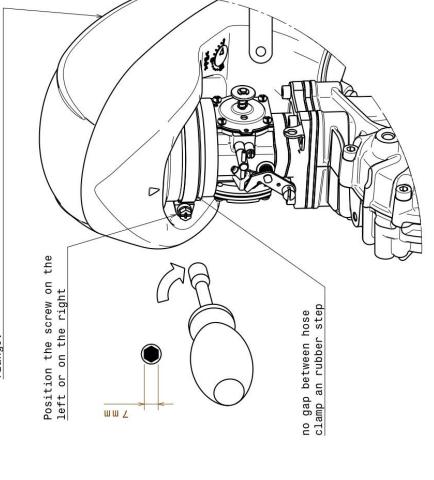
Push/Pull the airbox. There must be no relative ion between rubber sleeve and carburator inlet motion between rubber sleeve and flange.
