SERVICE BULLETIN – MOSTER185

Exhaust joint improvement, model My18-My19

1P04-0022_00 - Replacement bronze bush exhaust

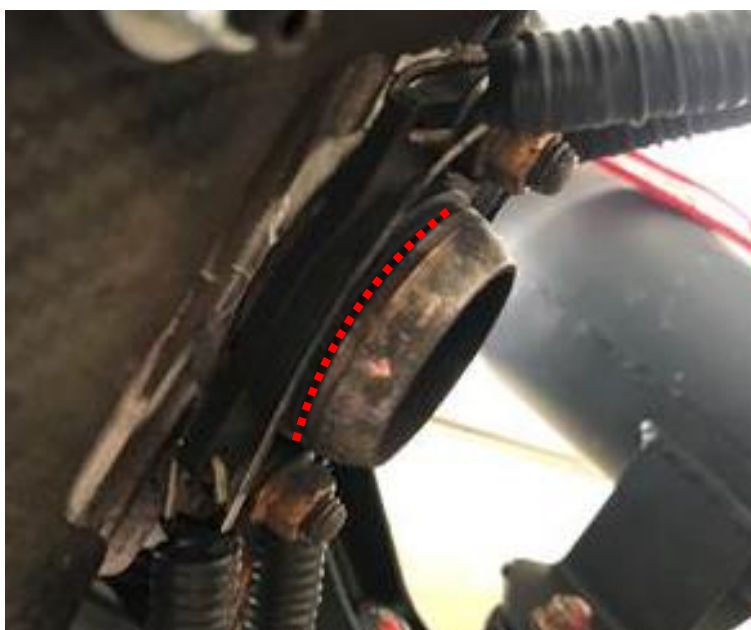
In some mufflers, after a few hours of operation in severe conditions, there is a step formation on the surface of the bronze ring. When this happens, the exhaust system loses the ability to rotate in this joint, causing severe stress to the sheets of the entire exhaust.

A kit has been created, compatible with the system and which brings some developments:

1. the different profile that avoids the seizure of the joint;
2. the change of the bronze alloy which improves the sliding and duration;
3. the lower load of the springs which decreases the mechanical stress on the parts involved.

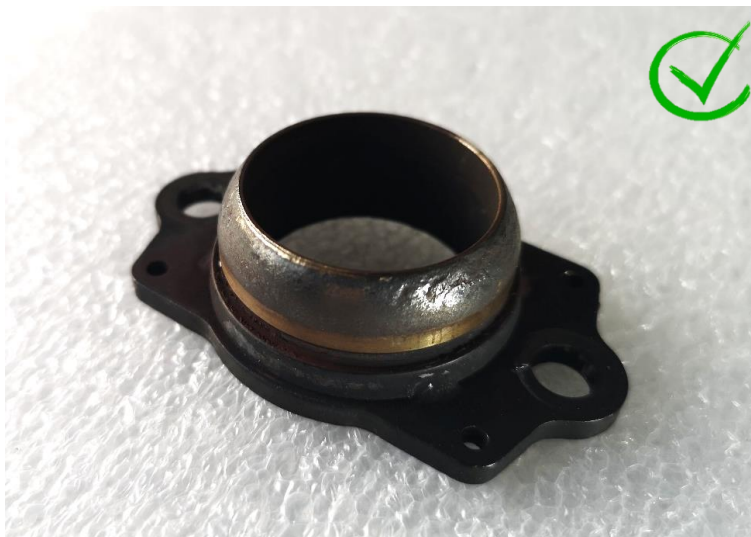
- with the new bush kit even in hard use conditions, the blockage due to steps have been removed. Periodic replacement of the brass ring remains the same: within 30 hours. Below a picture of the new bush that worked correctly for 30 hours.

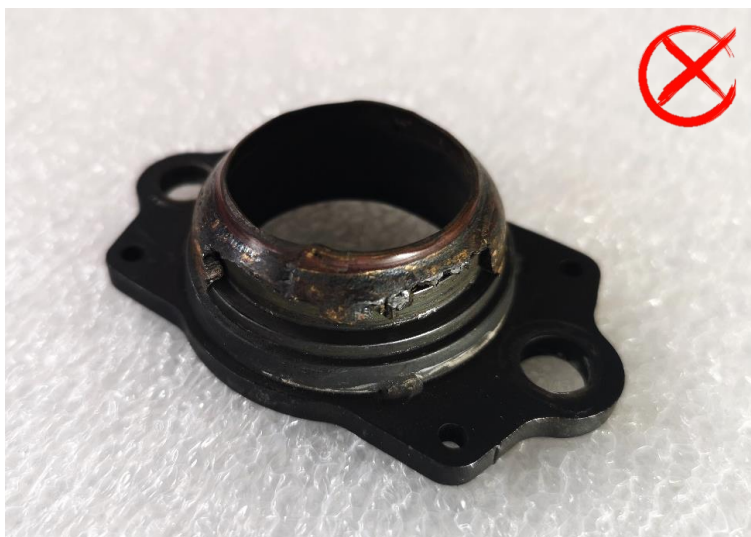
- In the next picture the previous series bushing, which worked for 30 hours in the same procedure test. The damage to the material and the steps that prevent the correct functioning of the joint system are clearly visible.
