Safety conditions and devices of the MY19 Airbox

MANDATORY

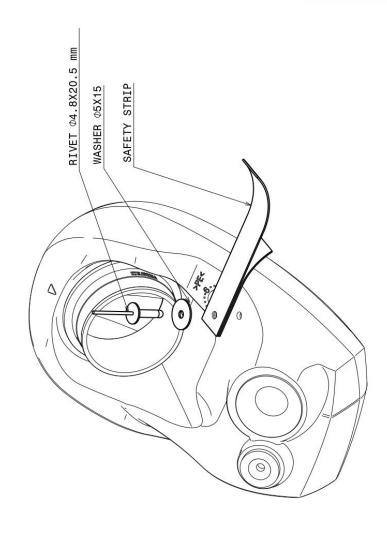
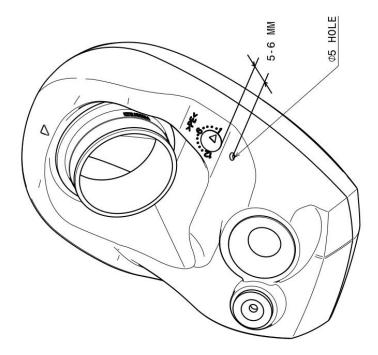
11. Alert conditions

Push/Pull the airbox. There must be no relative ion between rubber sleeve and carburator inlet motion between rubber sleeve and flange.
